# **INDOOR AIR QUALITY ASSESSMENT**

**Henry E. Warren Elementary School  
73 Fruit Street  
Ashland, Massachusetts**

Prepared by:  
Massachusetts Department of Public Health  
Center for Environmental Health  
Emergency Response/Indoor Air Quality Program  
July 2006

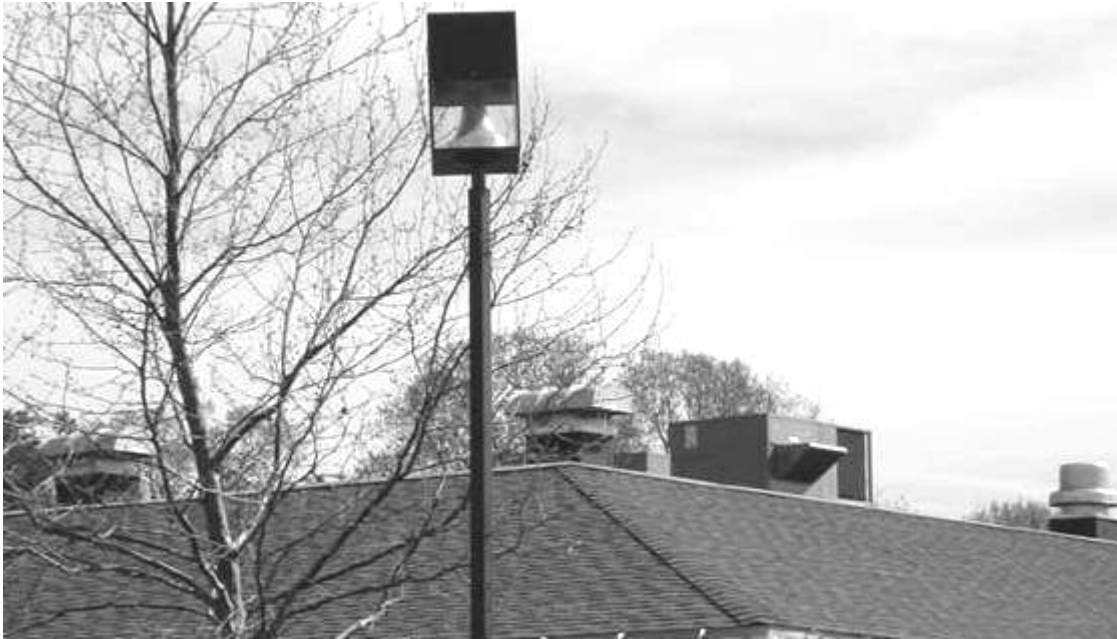
**Picture 1**

It is also likely that the flat section of the roof has little or no drainage. Over time, the weight of the rooftop HVAC equipment will create a depression in the roof allowing water to pool. The roof appears to have a slight pitch, which would direct water (albeit inefficiently) to the sloped sections of the roof to be collected into a gutter/downspout system at the roof edge (Picture 2). The system then appears to drain water to a dry well located to the east of the 1992 wing (Picture 3). The amount of water emptied by the gutter/downspout system appears to be substantial, as demonstrated by the scoured ground/lack of grass beneath downspouts (Picture 4). Substantial amounts of water appear to overflow the gutters, as evidenced by scouring lines in the dirt directly beneath the roof edge (Picture 5). HWES staff reported that the ground to the east of the wing is prone to flooding, which may indicate that the dry well is not connected to the storm drain system.

**HVAC Equipment on the Flat Roof, New Wing**

1. Consider consulting a building engineer on the appropriate manner by which water drains from the roof above the area of chronic water damage.
2. Remove wicks from all weep holes and clear obstructions to walls to maximize water drainage from exterior wall systems. Install appropriate media in the weep holes to prevent insect migration.

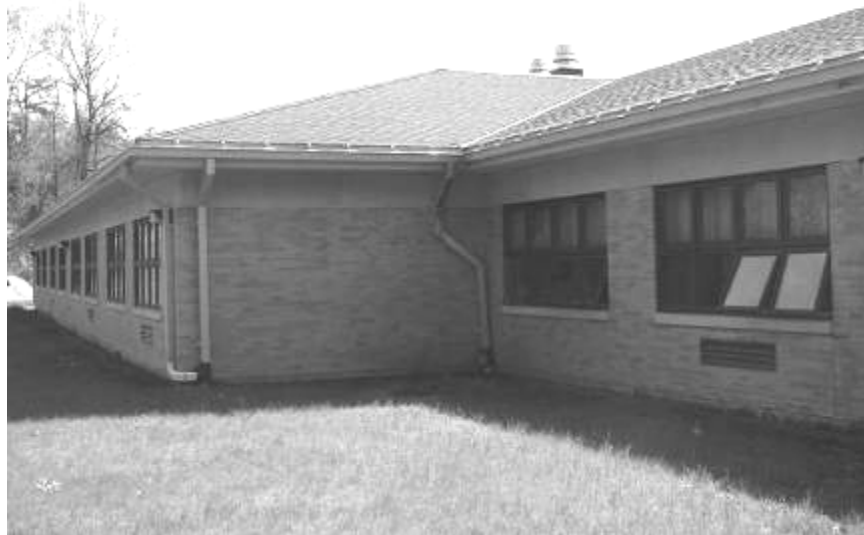
**Picture 2**

**Gutter/Downspout System**

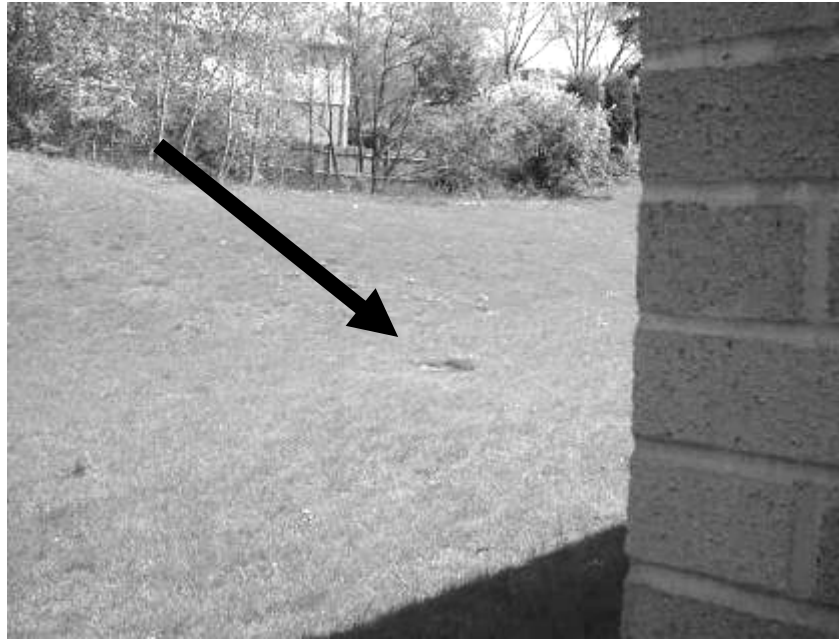
**Picture 3**

**Dry Well in Lawn to East of New Wing**

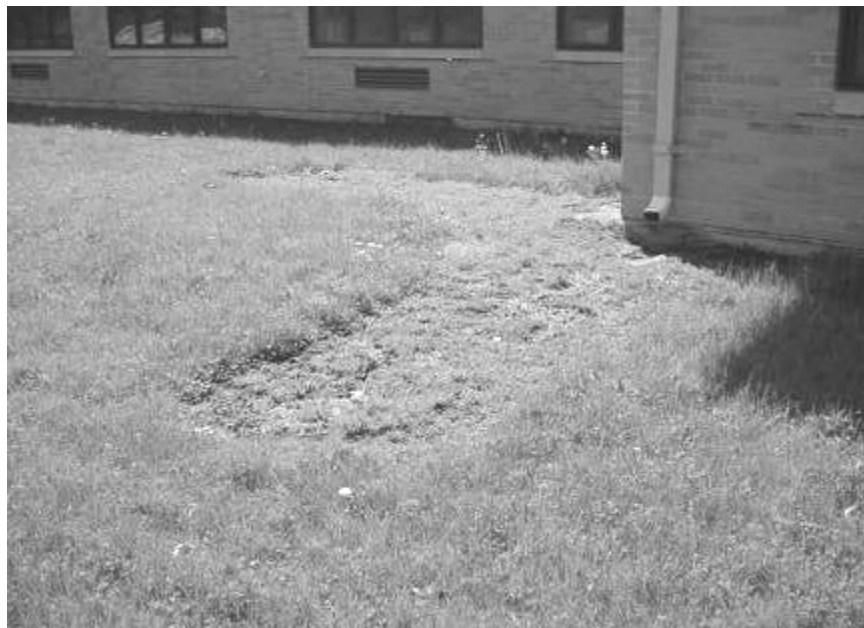
**Picture 4**

**Ground Scouring and Lack Of Grass beneath Downspouts**

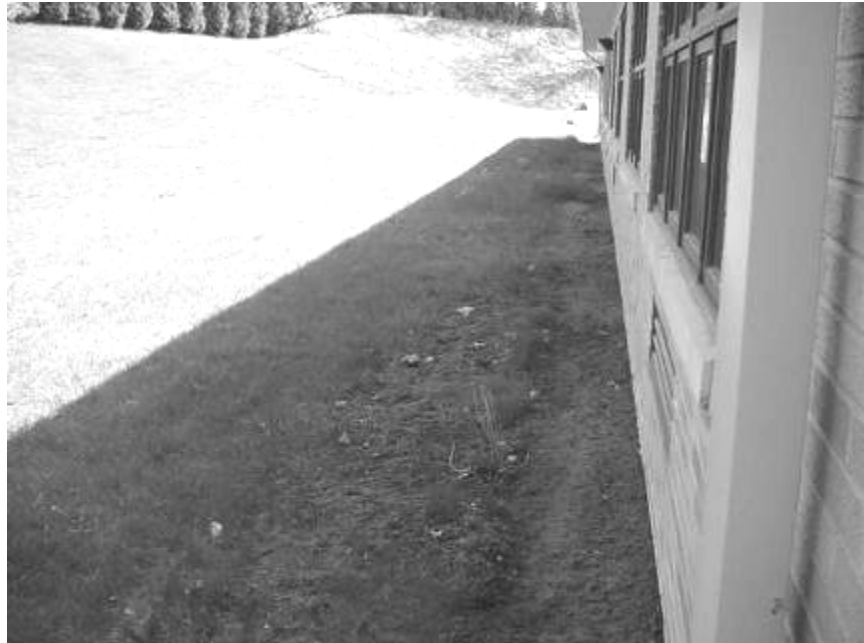
**Picture 5**

**Lines in Dirt Directly Beneath the Roof Edge**

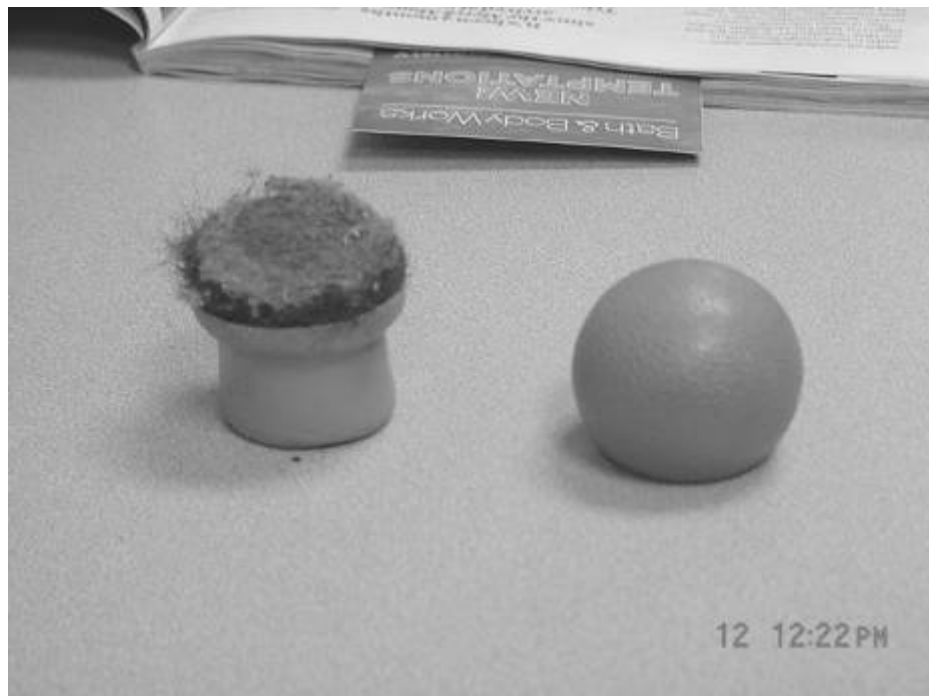
**Picture 6**

In an effort to reduce noise from sliding chairs, tennis balls had been sliced open and placed on chair legs. Tennis balls are made of a number of materials that are a source of respiratory irritants. Constant wearing of tennis balls can produce fibers and to off-gas TVOCs. Tennis balls are made with a natural rubber latex bladder, which becomes abraded when used as a chair leg pad. Use of tennis balls in this manner may introduce latex dust into the school environment. Some individuals are highly allergic to latex (e.g., spina bifida patients) (SBAA, 2001). It is recommended that the use of materials containing latex be limited in buildings to reduce the likelihood of symptoms in sensitive individuals (NIOSH, 1997). A question and answer sheet concerning latex allergy is attached as Appendix B (NIOSH, 1998).

**“Glides” for Chair Legs that can be used as an Alternative to Tennis Balls**

7. Discontinue the use of tennis balls on chairs to prevent latex dust generation. Alternative “glides” can commonly be purchased from office supply stores; see Picture 6 for an example.

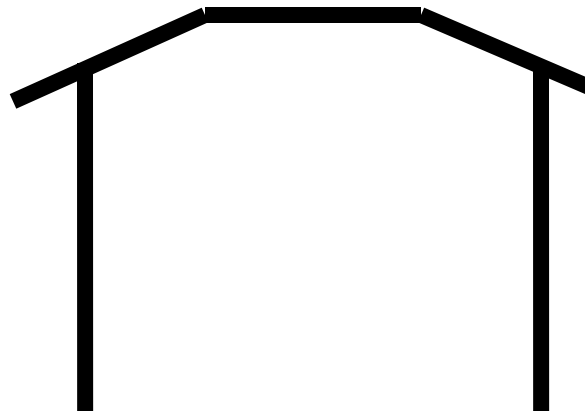
**Figure 3**  
**Truncated Mansard roof, HWES**

The 1992 wing has a truncated mansard roof (Figures 2 and 3), with a flat roof fitted over the center of the building instead of one with a slight peak. Installed on the flat section of the roof are air handling units that provide mechanical ventilation for offices (Picture 1). Water damage was observed beneath the junction of the flat/sloped areas of the truncated mansard roof or at the junction between the original and 1992 wing. This would indicate that the transition between the flat and sloped areas of the roof have either missing or incomplete flashing. In general, where two dissimilar materials meet on the exterior of a building, the

seam between them can serve as a point source for water penetration. The installation of flashing allows for water to transition from one surface to the next. Without proper flashing, water can penetrate through the seam resulting in water damage and potential mold growth.

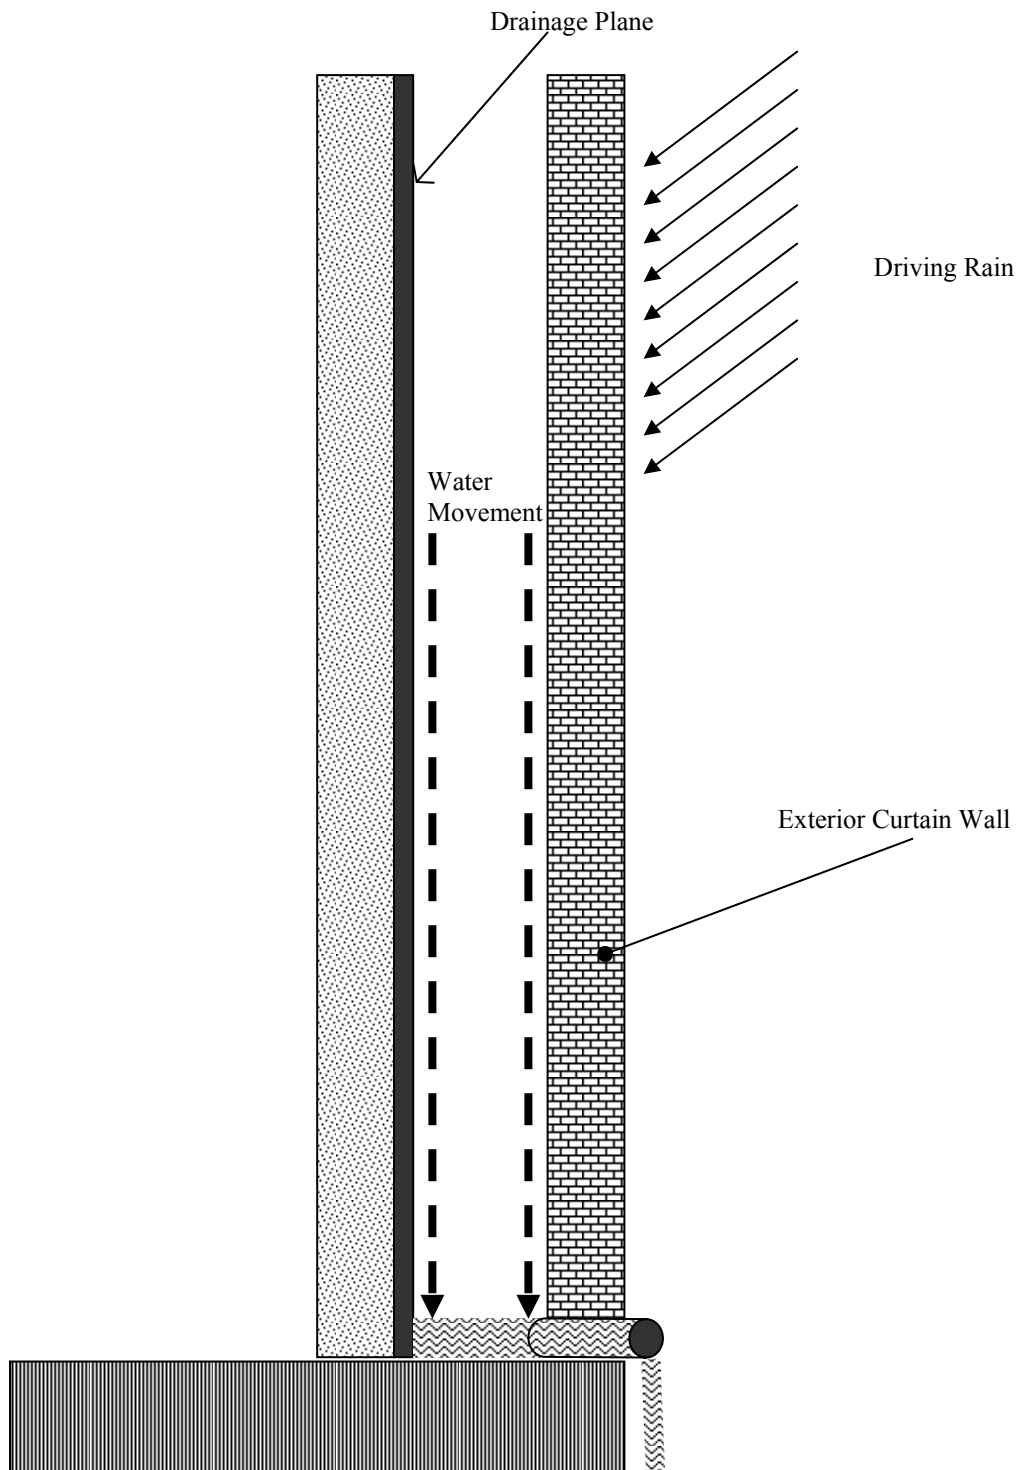
**Figure 4**  
**The Function of the Drainage Plane and Weep Holes to Drain Water from the Wall System, Prevent Moisture Penetration into the Interior**

Weep holes are customarily installed at or near the foundation slab/exterior wall system junction ([Figure 4](#)). Failure to install weep holes in brickwork or weep holes below grade will allow water to accumulate in the base of walls, resulting in seepage and possible moistening of building components ([Figure 5](#)). The exterior of the HWES consists of a traditional brick wall. An examination of the exterior brick walls outside of classrooms 2 through 11 was conducted to identify the location and condition of weep holes. Weep holes were found approximately at slab level. Of note is that each weep hole was blocked with a cloth/wick material, particularly rooms 9 through 11. Wicks were originally installed to enhance water movement from the drainage plane. Over time, sediment accumulation turns the wick into a stopper, which prevents water drainage from the exterior wall system. It is not recommended to “use ropes or tubes for weep [hole]s” (Nelson, P.E., 1999). Weep holes need to be open to facilitate the drying of exterior walls.
